# M/E CYLINDER LINER CONDITION MONITORING & RECONDITIONING SOLUTION

## Contact STX Service Singapore for Main engine Cylinder Liner Solution Service

### Main Engine Cylinder liner honing & Wavecut grinding service (Onboard & Workshop)

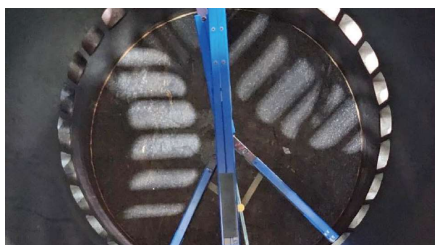
### Solution 1. Cyl. liner Inspection & Analysis (Onboard)

- Cylinder liner Measurement (LDM)
- Piston Ring Thickness Measurement (CTM)
- Cylinder liner condition photo (LLC)

✓ Only 1~2 hours is required per cylinder without removing cylinder covers.

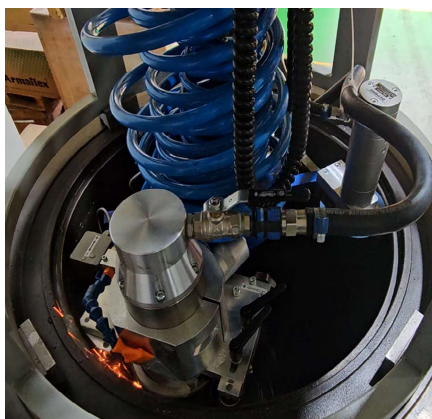
### Solution 2. Cylinder liner honing & wavecut grinding (Onboard or Workshop)

- Cylinder liner honing repair (HON2A)
- Cylinder liner wavecut grinding repair (WGM)
- Cylinder liner wear edge milling repair (VKS)

✓ Requiring 8~14 hours for honing and 6~10 hours for wave cutting repair per cylinder.

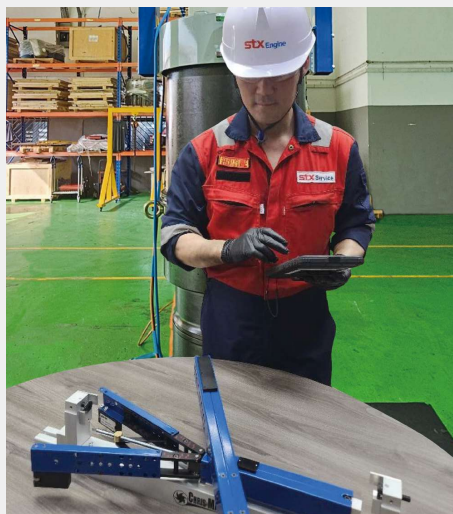
### LINER DIAMETER MEASURING INSTRUMENT (LDM)

| | For 2-stroke liners 500–980 mm bore |
| | Accurate measurement of cylinder wear and clover leafing without removing the cylinder cover |
| | Up to 26 measurement levels in about one hour per cylinder |

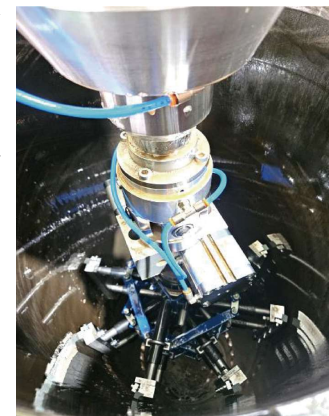
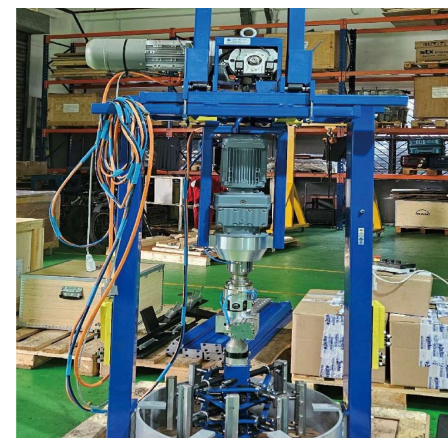
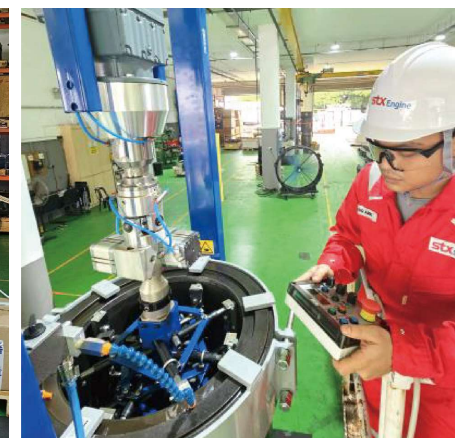
## STX CYLINER LINER HONING EQUIPMENT (HON2A)

Cylinder honing for 2-stroke engines is carried out using the HON2A machine.

Fully automatic cylinder liner honing machine for restoration of 2-stroke cylinder liner geometry and surface structure.

HON 2A efficiently rectifies the shape of the liner, removes scuffing and restores surface cross pattern. The machine is very easy to operate as it is fully automatic and electrically driven. In addition, it is preassembled, which means that setup-time is significantly reduced.

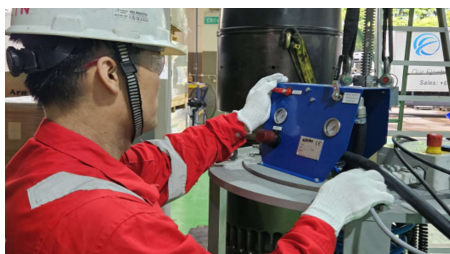
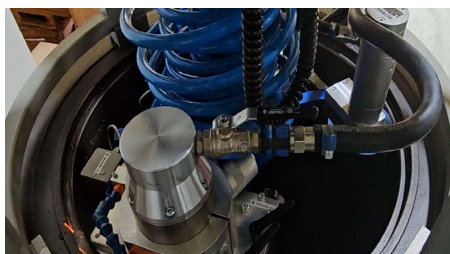
## WAVECUT GRINDING MACHINE (WGM)

For MAN cylinder liners, wave-cut grinding is recommended after honing. Wave-cut is a spiral pattern in the liner surface that acts as an oil reservoir and oil distributor in the liner surface.

The WGM is used after rough diamond honing and will create a wave pattern as shown above. Following wave-cut grinding, the cylinder liner needs to be finished through honing with fine ceramic stones. The total process time for WGM and fine honing is comparable to honing.

The wave-cut grinding depth can be fine-tuned with the remote control. The wave-cut pattern can be extended from the top of the liner down to the upper scavenge port level, but not in level with the scavenge air ports.

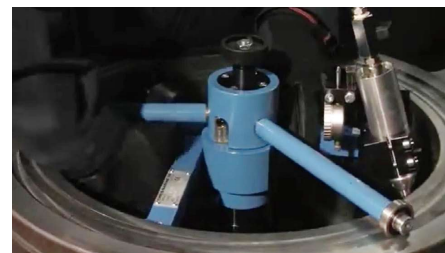
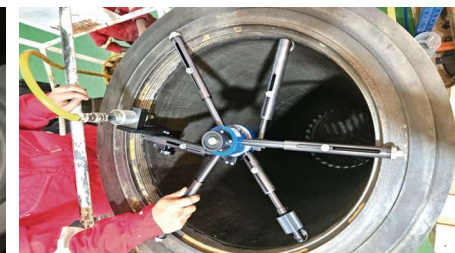
## WEAR EDGE MILLING MACHINE

The wear-edge grinder, VKS, is available as multi-bore version (for workshop use) and single-bore version (for on-board use). The VKS is an essential tool during piston overhauls when the wear edge has not been removed through honing. The wear-edge grinder removes some liner material thereby preventing hard contact between top piston ring and cylinder liner wear edge. Removing the wear edge by other means can damage the top piston ring and generate severe cylinder condition issues during running in of a new piston ring pack.

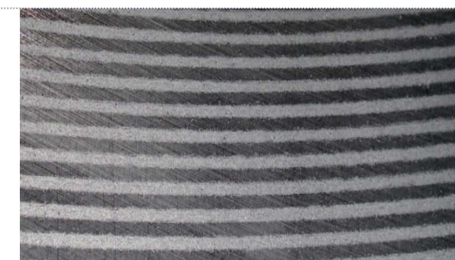
During the reconditioning service of a cylinder liner, wear edges will be removed, and the trumpet shape at the upper and lower ends of the liner will be smoothed. The clover pattern and ovality will also be eliminated before the surface structure is normalized to its original condition. If there are micro-cracks on the liner surface, they will be removed as well to prevent the liner material from breaking loose later. Any damages caused by bore polishing or micro-seizures will be addressed to restore the cylinder liner surface to its original state. All these actions will improve the piston ring function, thereby increasing the lifespan of the honed liners.

Finished honed liner surface roughness:  
Ra 0.4 – 1.6.

Condition of running surface after Cylinder Liners,  
Wave Cut and Honing.
